Seminar on
Managing Construction
Projects (Trends -
Present & Future)

Construction Management – Post Earthquake

N.K. Patel

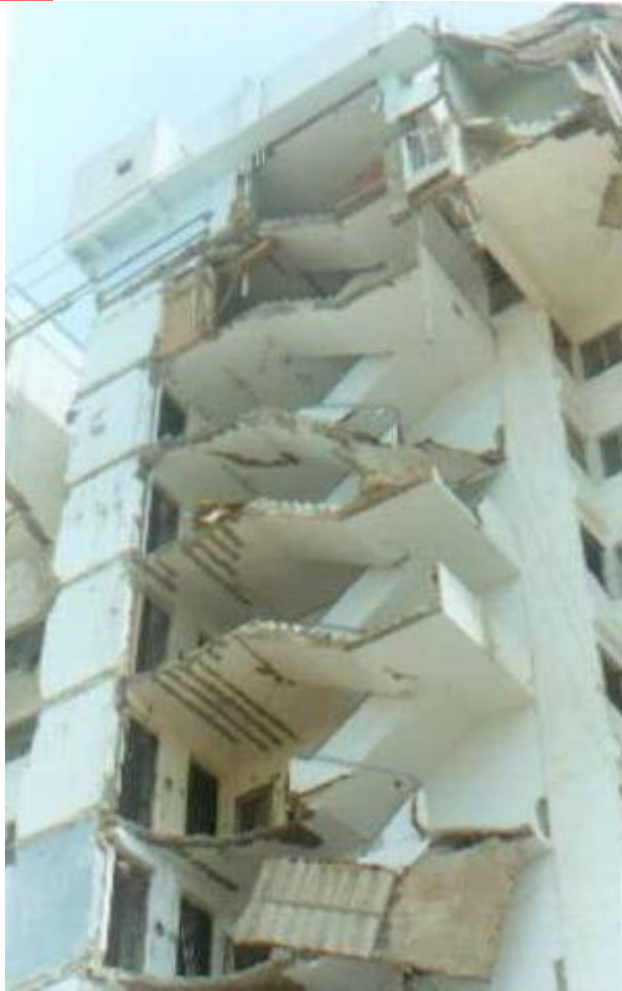
'Mansi',
Collapsed from stair
joint

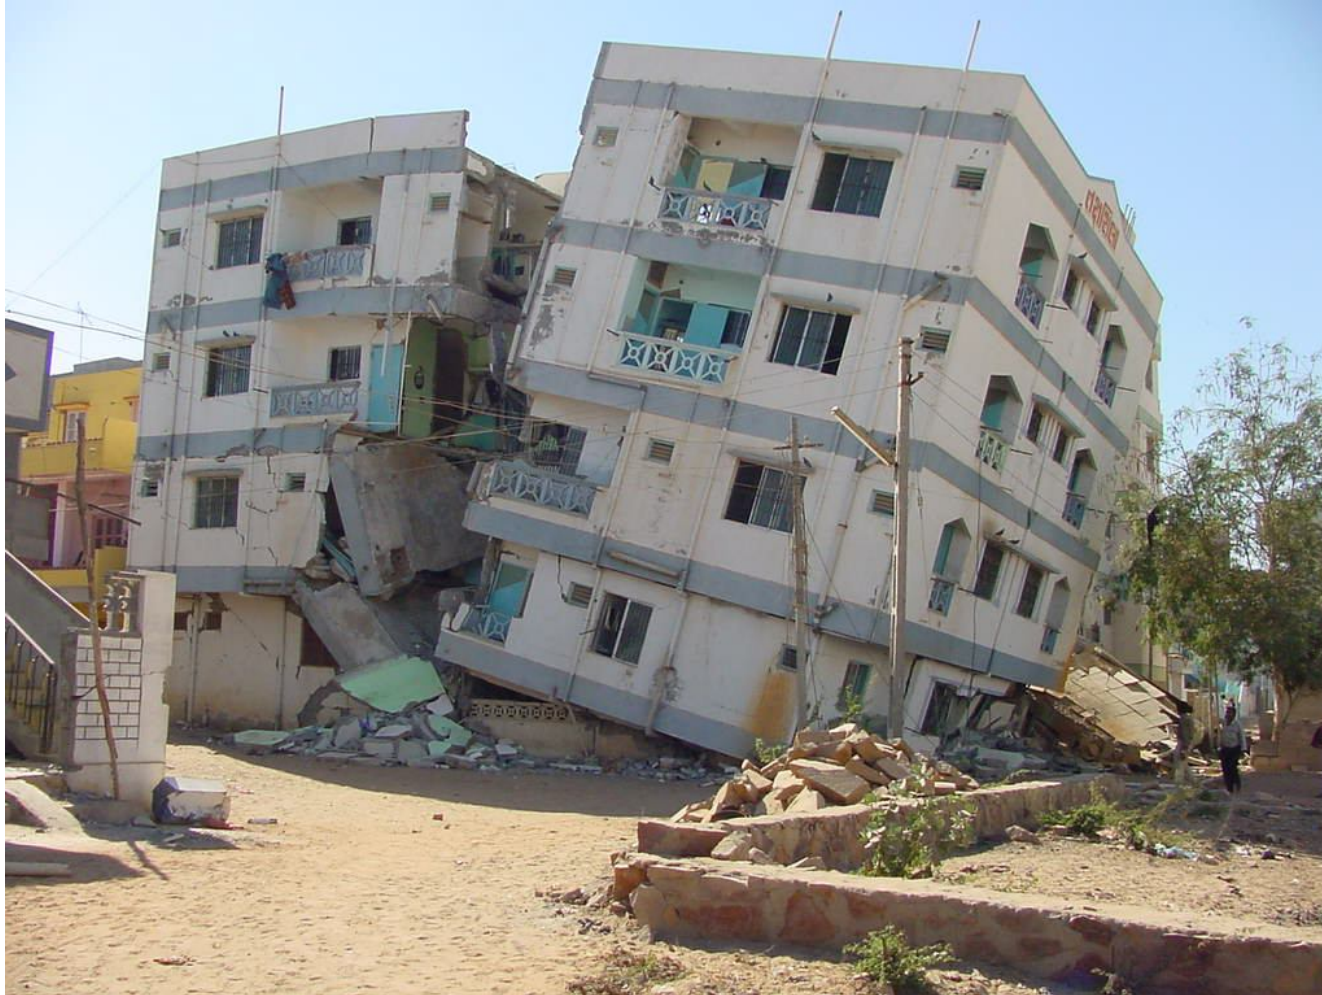
A split building.

Weak structural joint.

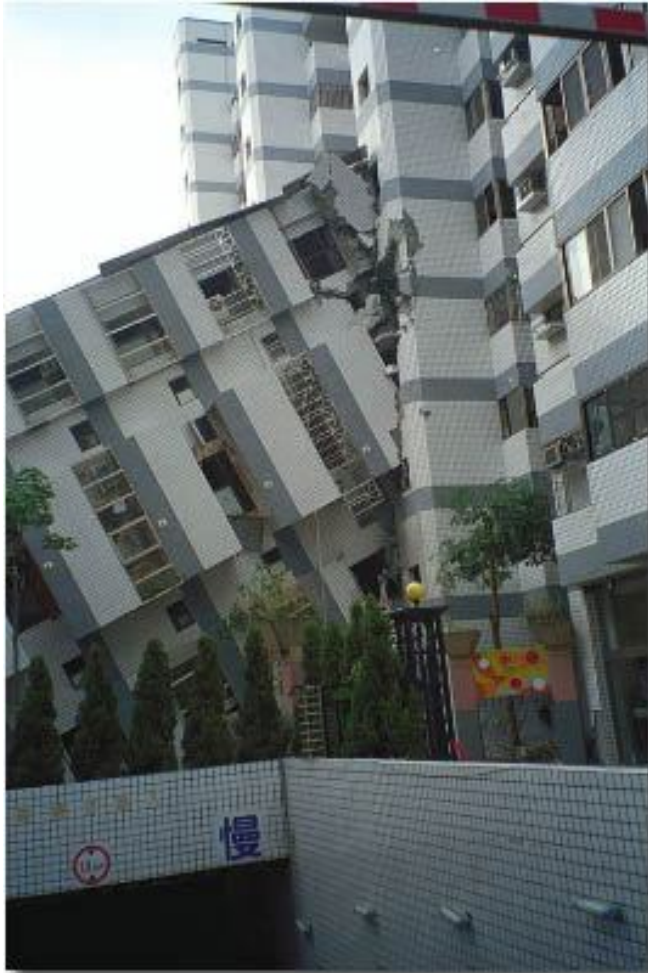
Hollow
Plinth
Collapse
in Highrise
